# RESTORING HISTORY

## 19<sup>th</sup> Century Stone Church Receives New Façade By John Grill, P.E., and Rex Cyphers, P.E.

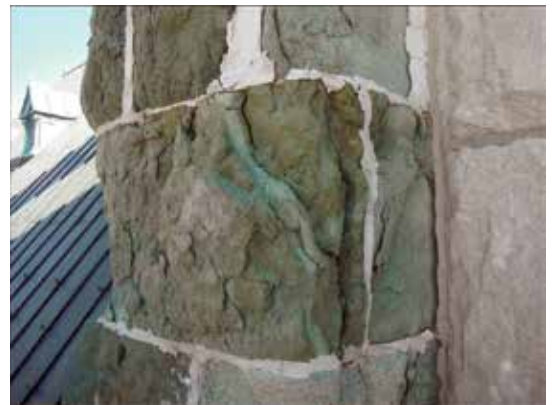
The field investigation revealed that the original construction of the walls, from exterior to interior, consisted of six- to eight-inch thick blocks of Pennsylvania ashlar greenstone, or serpentine stone, followed by a rubble masonry infill and two full wythes of brick masonry. The window surrounds were comprised of limestone, which was also employed at capstones and other decorative pieces. Copper elements appear on the church structure as well, most noticeably on the bell tower. Generally, the limestone was in good condition, but the serpentine stone had experienced significant distress.

Several restoration methods were evaluated, including consolidation treatments or using cast concrete to match the existing greenstone as outlined in historic preservation briefs. However, neither of these methods met the parish's long-term criteria, as the serpentine stone is typically not a good candidate for consolidation treatments and the stone deterioration was far too extensive and widespread.

*Deterioration of serpentine stone.*

Ultimately, the parish decided on a comprehensive overhaul of the entire exterior wall system. The existing greenstone and rubble masonry would be removed, the remaining brick would be repointed, and a new brick wythe and grouted collar joint would be installed behind new four-inch-thick granite stone. To ensure full integration of the new components with the existing limestone to remain, the pointing of the new granite coincided with repointing of the limestone.

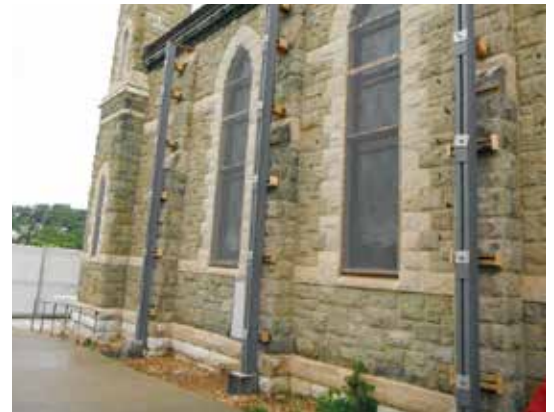
*External strengthening buttress.*

Removal of over half of the original wall thickness for the performance of the extensive repairs, without disruption of services, posed an installation challenge. A unique phasing plan and temporary external strengthening measures were developed to circumvent these challenges. External supports, consisting of steel columns anchored through the exterior stone masonry, were installed at the buttress locations. WDP performed a structural analysis to determine the maximum area of the wall that could be removed without compromising the overall stability of the structure. The results of the analysis dictated the phasing plan; small sections of stone and inner brick wythe were removed at a time, followed by repointing and installation of materials, including glass fiber reinforced polymer (GFRP) bars at areas of high tensile stresses, before proceeding to the next section. GFRP bars were selected for their high tensile capacity, small diameter, and the longevity provided by not being susceptible to corrosion. The external strengthening was removed at the completion of infill walls, and a similar sequence then occurred at alternating buttress locations. In using these methods, the exterior walls retained enough stability to resist out of plane loads and support the roof structure, even while over half of the overall wall thickness was removed.

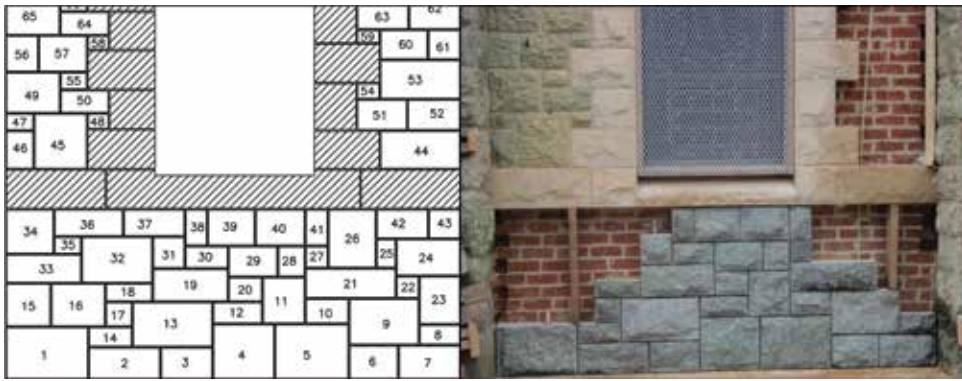
Granite shop drawing and field layout – each granite element is assigned a unique identification number.

The design accounted for the original look of the building, a concern of the local historic preservation council as well as the parish, by utilizing light imaging, detection, and ranging, or LiDAR. Scans of the existing church elevation were collected to ascertain the exact dimensions of every existing green serpentine stone and replicate them with mountain green granite stone. Extensive shop drawings assigned a unique number to every stone used in the wall. Each new granite stone matched the dimensions of the original serpentine with the exception of thickness to avoid additional loading on the foundation walls. The new stone was palletized and

shipped to the site by section number, and each section was laid out to check carefully for fit and dimension. Using granite stone rather than cast concrete provided a more durable façade while staying true to the traditional masonry construction methods. The laser scans ensured that the overall look of the church would not be changed, as the same stone pattern was precisely replicated.

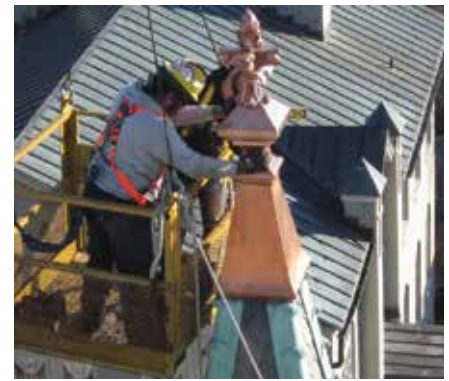
Replacement of copper narthex spire.

Various copper elements of the original structure had either deteriorated or fallen off the church entirely, including the copper spires of the bell tower which had been replaced with cast stone. As part of the restoration project, the original architectural details and the removed samples of intricate copper pieces were used to reconstruct replica copper details. Some of the more intricate pieces

were handmade in Germany. Dentil courses, spires, and decorative elements were replicated to match the original church construction.
