# RESTORING HISTORY

## 19<sup>th</sup> Century Stone Church Receives New Façade By John Grill, P.E., and Rex Cyphers, P.E.

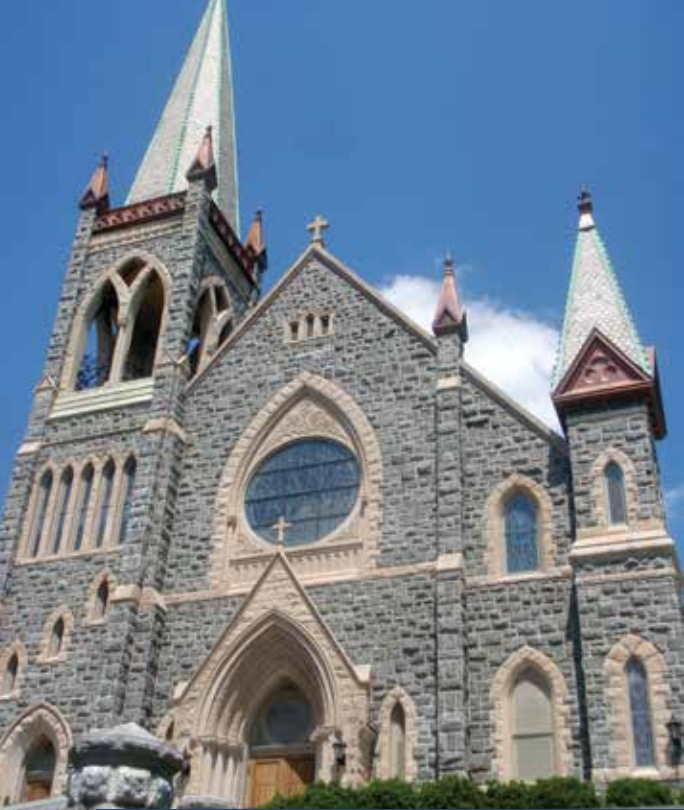
The field investigation revealed that the original construction of the walls, from exterior to interior, consisted of six- to eight-inch thick blocks of Pennsylvania ashlar greenstone, or serpentine stone, followed by a rubble masonry infill and two full wythes of brick masonry. The window surrounds were comprised of limestone, which was also employed at capstones and other decorative pieces. Copper elements appear on the church structure as well, most noticeably on the bell tower. Generally, the limestone was in good condition, but the serpentine stone had experienced significant distress.

*Deterioration of serpentine stone.*

Ultimately, the parish decided on a comprehensive overhaul of the entire exterior wall system. The existing greenstone and rubble masonry would be removed, the remaining brick would be repointed, and a new brick wythe and grouted collar joint would be installed behind new four-inch-thick granite stone. To ensure full integration of the new components with the existing limestone to remain, the pointing of the new granite coincided with repointing of the limestone.
